**EXXONMOBIL CHEMICAL COMPANY
HIGH LEARNING VALUE INCIDENT REPORT ⁽¹⁾**

A. Site	ExxonMobil Chemical Central Europe GmbH
B. Date/Time	Date: 30.07.2004 Time: 11:58
C. Contact Name	Volker Hake, CF-EMT +49 221 770 3580
D. Equipment Involved	Electric Substation Type: AEG SV90/91

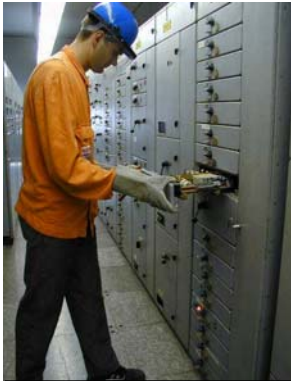
E. Incident Description (Factual description of key events and consequences.)	CMP Plant had a near-miss while replacing a shutter (Photo 1) on the 400 V substation. The station and spare parts are 28 years old. Root Cause: the control-switch, located at the end of the shutter (Photo 3 @ bottom right hand), had a hairline crack in the switch casing; casing broke when closing the shutter and caused the shortcut. Other unused spares of shutters of same type already showed some of the same hairline cracking of the switch casing (Photo 4). No injury as electrician wore proper PPE and closed front of shutter protected against electric arc.

(1) Insert shutter, Face shield and special gloves

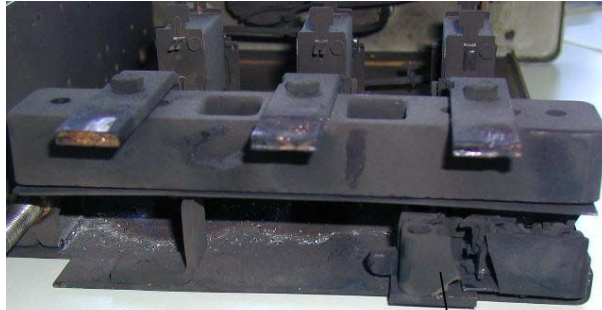
(2) Electrical contacts at rear of shutter

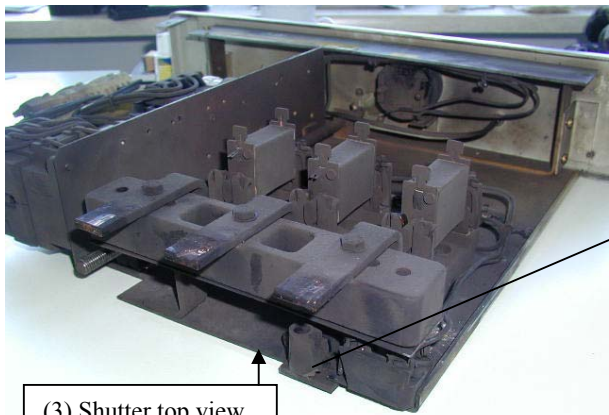
(3) Shutter top view

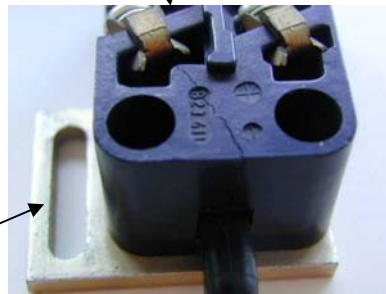
F. Causes Direct Causes and Root Causes, including Human Factors.	The direct causes : Hairline crack of the switch casing due to 28 year old spare parts not identified at replacement. The supplemental causes :

G. Risk Potential (Per OIMP Template)	Risk identified for this type of shutter: C III. If shutter would had open front, risk would be C II.
H. Applicable OIMS requirement and/or local practices	Wear specific PSE for work at electric substations Only electricians are allowed to work at substations and they do not work alone

(4) Hairline crack of the switch casing

I. Learnings and Recommendations (Brief description of major learning's and key recommendations which are likely to benefit others)	Recommendation: Whoever has similar old spare parts please check carefully the casing of the control-switch up-front assembling of these old spares

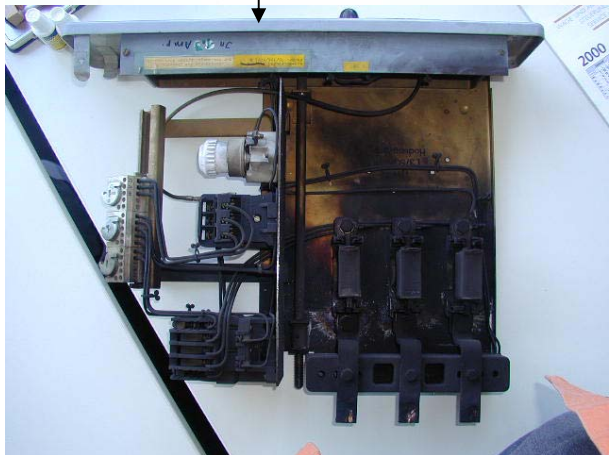
Metal front and bottom prevented electric arc from creating more damage to other parts of substation and to hurt electrician.
